Documenta Ophthalmologica 64:143–152 (1986)
© Martinus Nijhoff/Dr W. Junk Publishers, Dordrecht — Printed in the Netherlands

Degradation of polypropylene in the human eye: A sem-study

W.L. JONGEBLOED¹ and J.F.G. WORST²

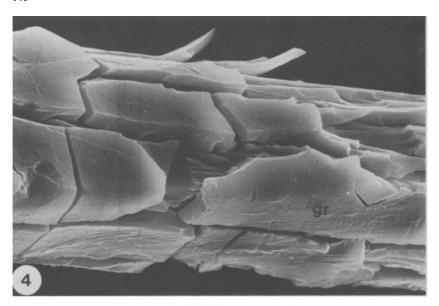
The polypropylene suture which had been in the human eye for $6\frac{1}{2}$ years as fixation suture for an IOL is shown at low magnification in Figure 1. The left end (l) and the right end (r) of the suture show a considerable decrease in suture diameter in comparison with the central part (c). The right end had spontaneously broken, while the left end was cut off to free it from the surrounding tissue.

Figure 1. Polypropylene suture which remained for $6\frac{1}{2}$ years in a human eye as a fixation suture; 1 = cut-off end, diameter appr. $100 \, \mu\text{m}$; r = spontaneously broken off end, diameter appr. $60 \, \mu\text{m}$; c = central part, not in direct contact with tissue, diameter $200 \, \mu\text{m}$. Magn. $20 \times$.

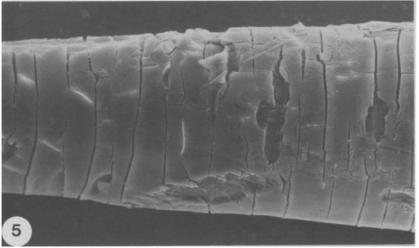
Figures 2 and 3 represent parts of the left side of the suture, cracks perpendicular to the longitudinal axis of the suture are visible. Lumps of the surface layer are nearly detached or are already missing (arrows). Note also the irregularity of the diameter of the suture in both pictures.

Figure 2. Part of left side of suture of Figure 1, showing cracks in surface layer and missing part of surface layer (arrows); note irregular diameter. Magn. $225 \times$.

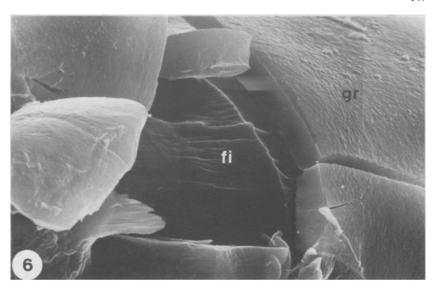
Figure 3. Part of left side of suture of Figure 1, showing cracks in surface layer and nearly detached lump of surface layer (arrow); note somewhat twisted shape of suture. Magn. $325 \times$.

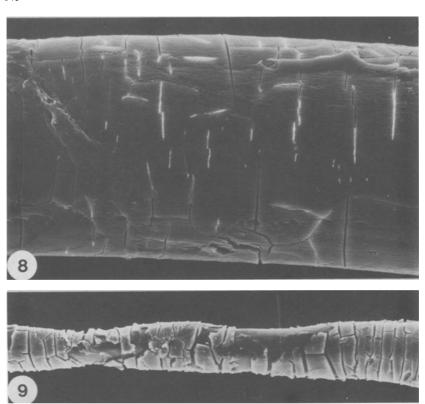
Figures 6 and 7 represent details of Figures 3 and 4 respectively, showing the subsurface layer after splitting off of the lumps of the surface layer. The subsurface layer shows a fibrillar character and the splitting off

Figure 6. Detail of Figure 3 showing subsurface layer with fibrillar character (fi); note thin organic deposit with granular character (gr) on outside of lumps of surface layer. Magn. $2000 \times$.

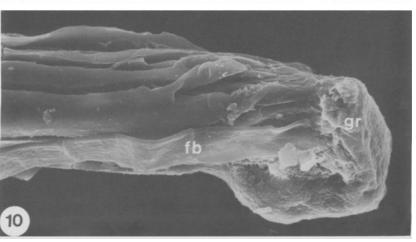
Figure 7. Detail of Figure 4 showing splitting of surface layer from underlying layer with fibrillar appearance (fi); lumps covered with somewhat granular material (gr). Magn. $2000 \times$.

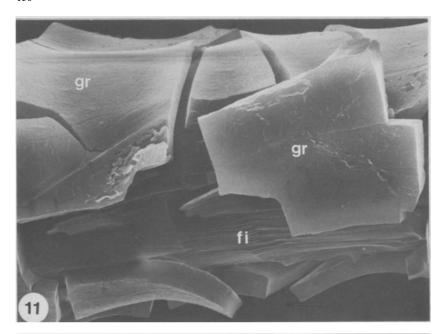
Figure 11 shows the destruction of the polypropylene in a rather dramatic way; the complete surface layer has broken into pieces, exposing the subsurface layer. The outside layer is covered with some deposits, mainly of a granular nature.

Figure 11. Part of right side of suture of Figure 1 showing almost complete degradation of surface layer, large lumps have detached exposing subsurface layer with fibrillar character (fi). Note granular deposit on lumps (gr). Magn. $975 \times$.

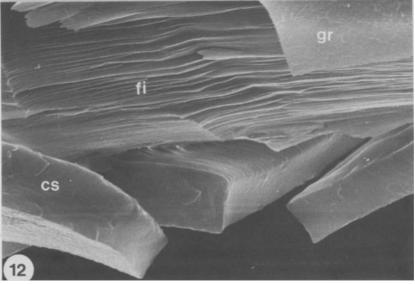
The subsurface layer is observable in more detail in Figure 12 (detail of Figure 11); the fibrillar character of this layer is clearly visible, while the splitting of the surface layer is noticeable, particularly at the cross-sections of the split-off lumps in the lower part of the picture.

Figure 12. Detail of Figure 11 showing subsurface layer (fi) and split-off lumps of surface layer in more detail (cs). Magn. $2500 \times$.

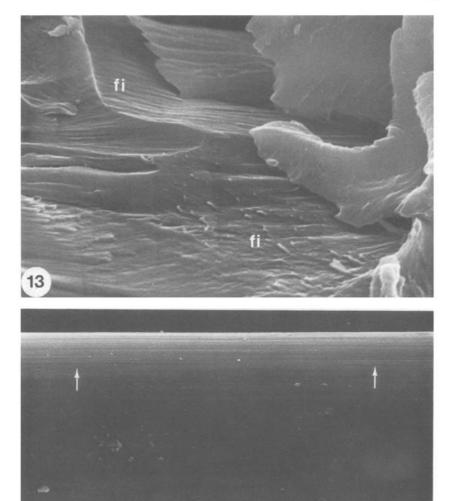
The fibrillar character of the subsurface layer, and the irregular splitting of the surface layer from the underlying layer as the result of a chemical change in the surface layer, are shown in more detail in Figure 13.

Figure 13. High magnification of subsurface layer after detachment of surface layer; note irregular splitting effect due to chemical change in polypropylene. Fibrillar character (fi) of subsurface layer clearly observable. Magn. $5000 \times$.
